# Effect of roofing material on quality of roof-harvested rainwater-correlation with rainfall events

# I. Petousi<sup>1</sup>, G. Daskalakis<sup>1</sup>, M. Fountoulakis<sup>2</sup>, A. Papadaki<sup>1</sup>, C. Tsompanidis<sup>1</sup>, <u>E.</u> <u>Dialynas<sup>2</sup></u> and T. Manios<sup>3</sup>

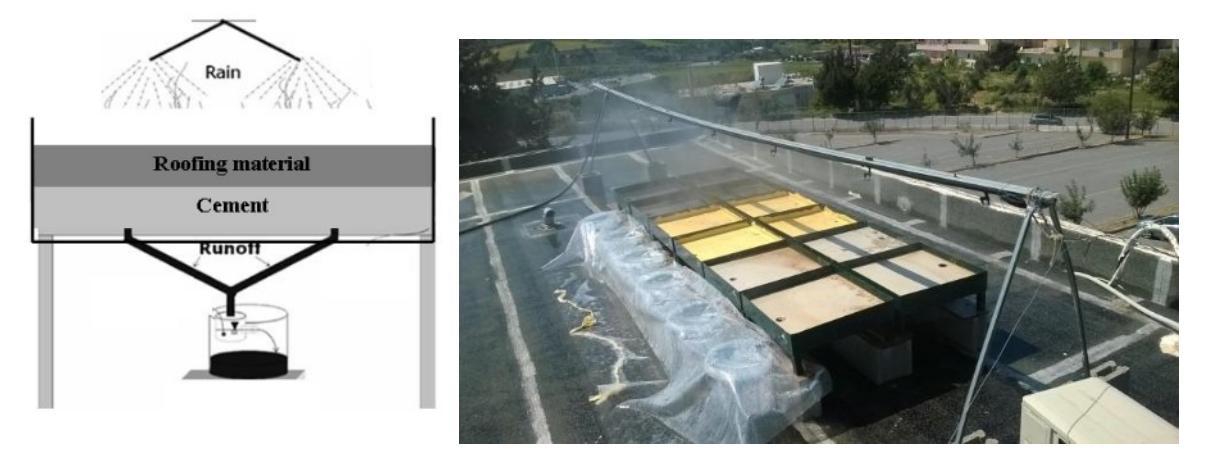
Three roofing materials were selected for the construction of lab-scale roofs: cement, asphalt and granite. Fig. 1 shows a schematic diagram of the pilot-scale design. The rain was

made possible by spray emitters covered the total area for each tray. A drainage system was placed in the bottom of each tray. During the experiment, three precipitation rates (12, 22 and 34 mm/h) and five antecedent dry weather periods (1, 3, 7,14 and 28 days) were examined, for all roofs. Harvested rainwater were collected and separated in three different qualities : a) first 0.2 L (S1), b) next 0.3 L (S2) and c) next 0.5 L (S3).

Figure 1. Schematic diagram and general view of lab-scale roof
